FUSS & O'NEILL

Manufacturing Solutions, LLC

What is that unpleasant grinding / squealing noise under the Guard ?

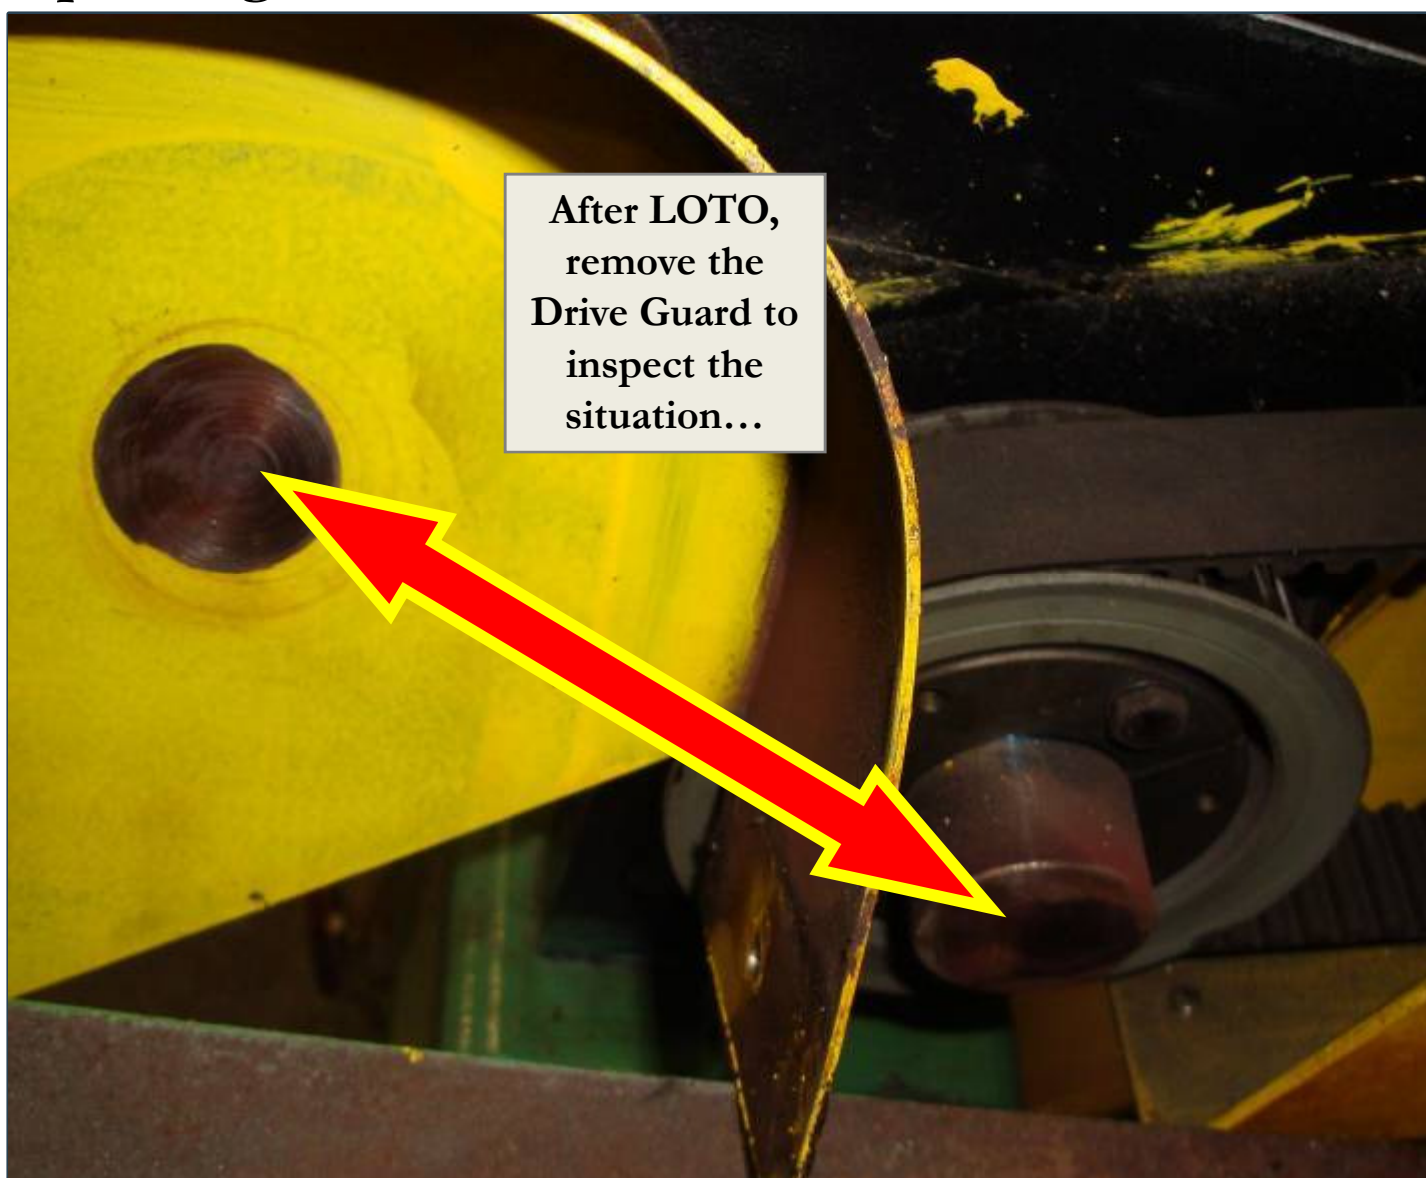
Most likely you will find the guard rubbing on the drive shaft end (notice the paint is missing). Simply fasten the guard away from the shaft in the slots provided.

After LOTO,
remove the
Drive Guard to
inspect the
situation...
